Manhole Inspection Summary

Manhole # S31AA1008MH

Insp Date: **7/31/08 1:53 PM**

Location Address: **SAN MARTIN DR**

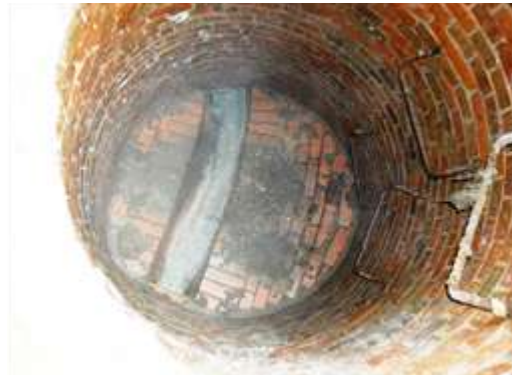
Top View

Corbel infiltration. Evidence of surcharge - Bench debris.

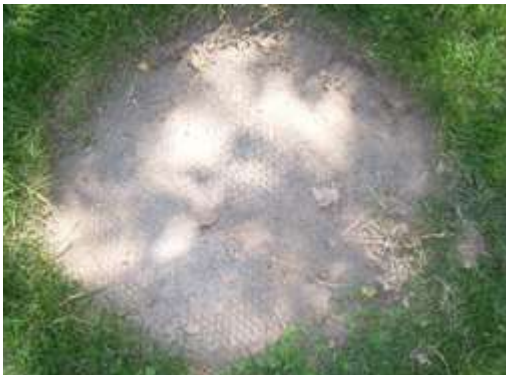
Partially Buried

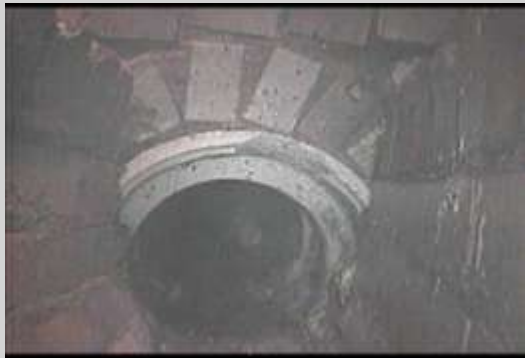
10 in. Circular Gravity Sewer Pipe Out @ 12 O'Clock

Deposits: ☐ None ☐ Mud ☐ Sludge ☐ Debris ☒ Grease

Silt Depth: **0** (in.) Deposits Extent: **Light**

Infiltration: **None** Pipe Seal Cond: **Broken**

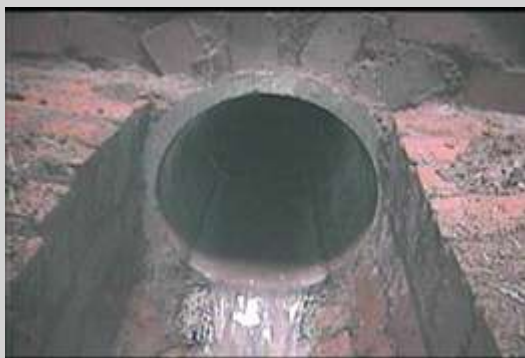
10 in. Circular Gravity Sewer Pipe In @ 7 O'Clock

Deposits: ☒ None ☐ Mud ☐ Sludge ☐ Debris ☐ Grease

Infiltration: **None** Pipe Seal Cond: **Unknown**
